A Study To Determine The Quality Of Building Stock And Earthquake Risk In Kirsehir

Mehmet Mustafa Önal, Seda Çellek

5. THE EVALUATION OF THE BUILDINGS IN KIRSEHIR PROVINCE KIRSEHIR

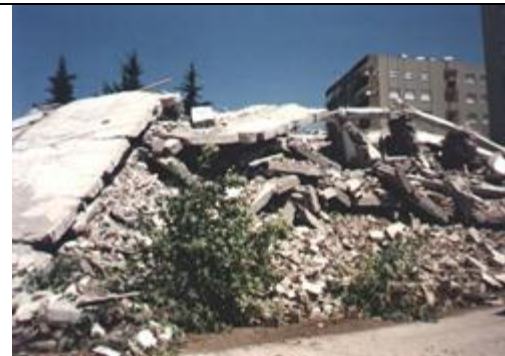
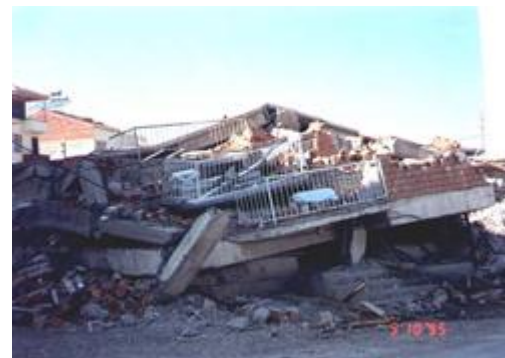
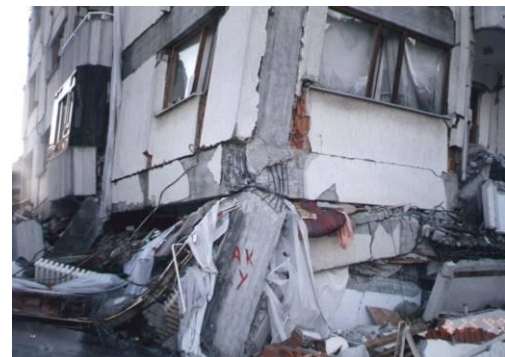
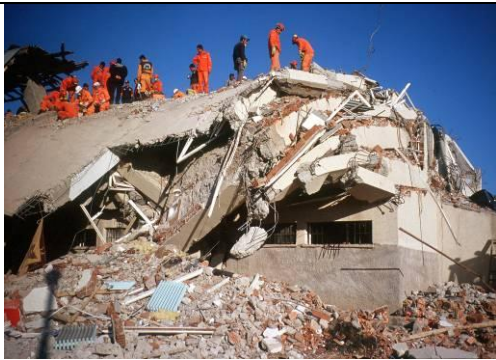
Fig. 1 Buildings that were damaged in the earthquakes, a) 13 March 1992 Erzincan Earthquake, b) 1 October 1995 Dinar Earthquake, c) 17 August 1999 Golcuk Earthquake, d) 1 May 2003 Bingol Earthquake the caption.

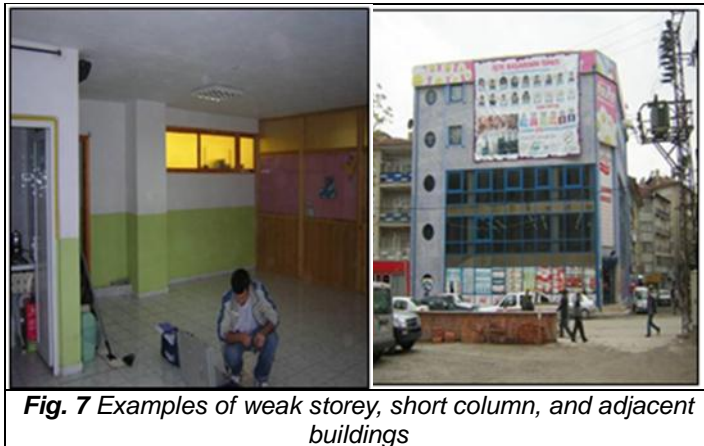
Defects were observed nearly for all buildings. The most common defects among the others are insufficient reinforcement, weak storey, short column effect, and hammering effect during the earthquake caused by different storey levels of the adjacent buildings (Figure 7). Interesting findings were also obtained from the concrete strength detection of the buildings. Minimum compressive concrete strength in the earthquake regions was required as C20 following the change in the Turkish Earthquake Regulations in 1998. The compressive concrete strength value of the sampled buildings constructed before 1998 was determined as 8-12 MPa while this value was determined as 16-22 MPa for the ones constructed after 1998. Corrosion and, accordingly, damage in the structural elements were detected in most of the buildings. The buildings were classified into 4 groups, according to their possible damage (Table 3).

**Fig. 7** Examples of weak storey, short column, and adjacent buildings

Kirsehir province, like some other provinces, is among the regions where the earthquake region coefficient was changed and the quality of the building stock is rather unspecific. The damage ratio compared to the earthquake magnitude has been unfortunately very high observed from the recent earthquakes. Therefore, the need for the investigation of the Kirsehir building stock, having 42057 buildings in the city center, has emerged. A high ratio, 85%, of the investigated buildings is under risk as observed from the results of the investigations. On the other side, it is possible to state that the masonry buildings, which were not investigated in this study, also fall into this risk group. Thus, retrofitting works should be initiated as soon as possible starting with the buildings at the high risk group.
