Analysis Of Vacuum Failures During Curing Of Cfrp Composites.

Mr. K.Vijaya Kumar, Dr. Mir Safiulla, Dr. A.N Khaleel Ahmed

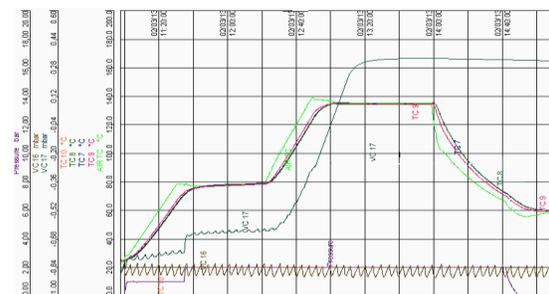
A root cause analysis has carried out considering from the Layup stage to the curing stage of 10 complex structural parts. It is observed that the vacuum bags fail during curing process as shown in fig.1 due to a) Improper bagging techniques. b) improper placement of valves during bagging c) Leakage in vacuum hoses & valves d) Resin block in tool vacuum lines e) malfunctioning of vacuum controllers / solenoid valves

Fig.1 Shows the vacuum failure during curing where the vacuum failed at elevated temperature (135 deg.C)

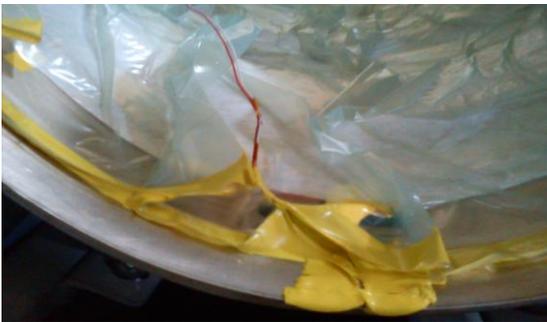
Fig.3 Thermocouple pulled out during curing that leads to vacuum failure.

Vacuum is applied between the bagging material and the material being cured such that the plies of material are compressed through the thickness against the mold. In some instances, an interim debulk step to enhance the quality of the finished product through improved consolidation. After vacuum bagging the vacuum leak rate from the bag is to be ensured before loading the part in to the autoclave for curing. Generally the allowable leak rate is only 50 milli bar for 5 mins. If the bagging is improper the leak rate will be more, generally the vacuum leak will be at thermocouple connection loops as shown in the fig.3 where the thermocouple is pulled out due to turbulence of air in the autoclave as the sealant becomes soft after heating. Hence it is recommended to provide the inbuilt thermocouples along with the tools and proper sealing to be ensured at the thermocouples provided for the part end.

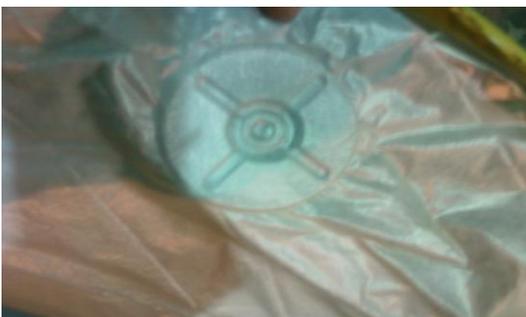
If the vacuum valves are not placed properly on the breather then the vacuum flow will be blocked as a result white patches or the voids in the cured part as shown in the fig.4.

Fig.4 Improper placement of valve, where the vacuum flow is blocked.

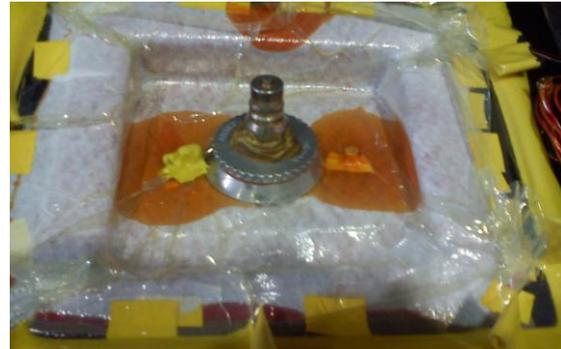
Even when the valves are placed on the part with insufficient layers of breather over the part or using a thin breather the resin enters the vacuum valves through the breather as shown in the fig.5 Due to this the volatile gases will be retained in between the layers and leads to defects like voids and improper distribution of resin, Hence the valves are to be placed on the ends with proper layers of breather to avoid direct contact of the resin to the valve.

Fig.5 Resin collection in the vacuum valve due to the use of thin breather, where the vacuum flow is blocked.

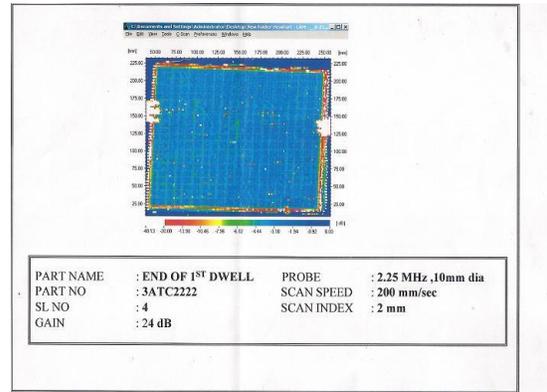
Fig.11 Ultrasonic ‘C’ Scan view of the specimen cured after vacuum vent out at the End of first dwell (75 deg.C)

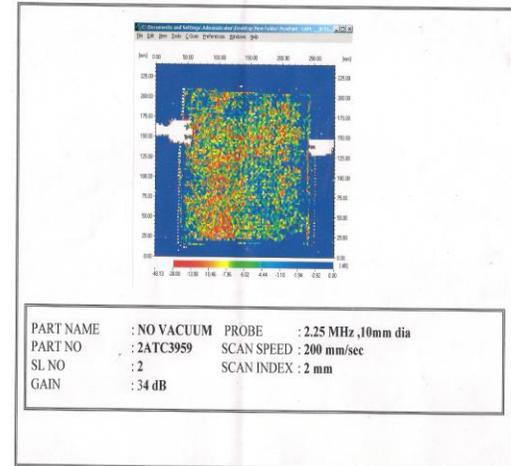
All the specimens were tested for compaction using the A Scan & C-Scan and found the attenuation level was high for the specimen cured without vacuum through out the cure cycle, and also it was observed white patches which indicate improper resin flow and compaction due to insufficient vacuum during gellation. As shown in **the table 1&2.**

Fig.12 Ultrasonic ‘C’ Scan view of the specimen cured without vacuum, the yellow spots indicate the existence of Voids in the laminate.

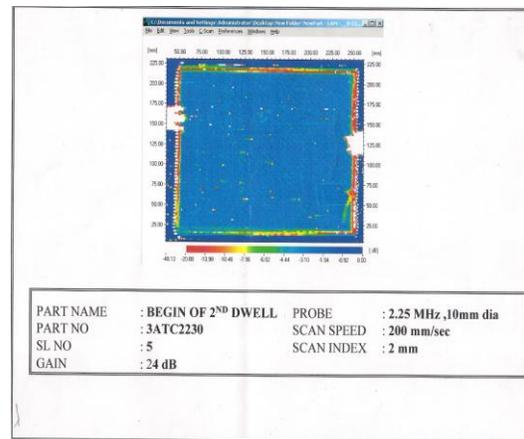
Fig.13 Ultrasonic ‘C’ Scan view of the specimen cured after vacuum vent out at the begin of second dwell (135 deg.C)

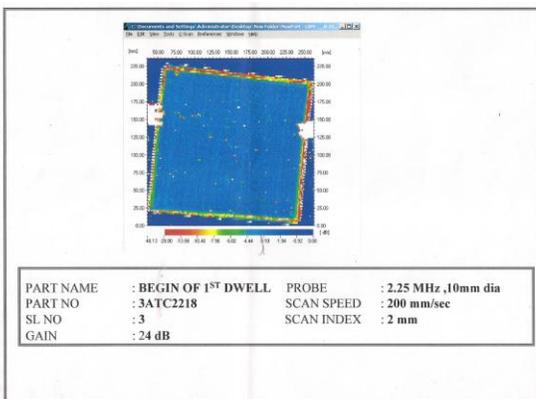
Fig.10 Ultrasonic ‘C’ Scan view of the specimen cured after vacuum vent out at the begin of first dwell (75 deg.C)

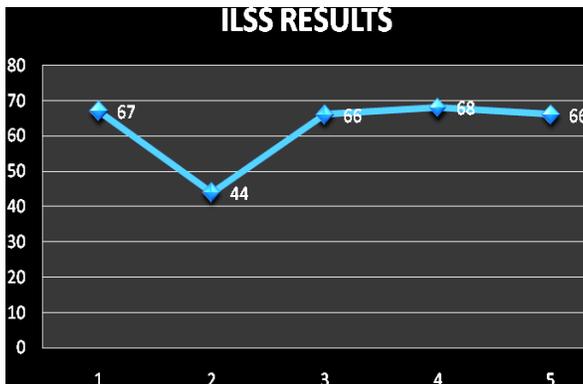
Fig.14. ILSS values curve of the specimens, where the specimen no.2 indicates low strength.

From the table. 3 it is noticed that the Interlaminar Shear strength (ILSS) is very low for the specimen which is cured without vacuum. This signifies that the presence of voids and the compaction of the layers is poor, as a result all the mechanical properties like tensile, flexural and the stiffness will be low. Whereas the other specimens exhibit appreciable strength equal to the reference laminate. Hence the existing cure cycle recommends for the vacuum through out the cure cycle and by this experiment it is evident that the cure cycle can be modified so as to save the power and curing cost. In the recommended cure cycle shown in fig.15 the vacuum can be cut off or vented out at 80 deg.C after the application of pressure that over comes the static vapor pressure of the resin.
