The Monitoring Results Of The Current Technical Condition Of The Architectural Heritage Of Juma Mosque In Khiva

Gavhar Durdiyeva

Abstract: This article illustrates the technical condition of the architectural monument reflected in the results of the monitoring results Juma mosque, where is located in Khiva "Ichan Kala" museum reserve which is in the hereditary cities list of UNESCO.

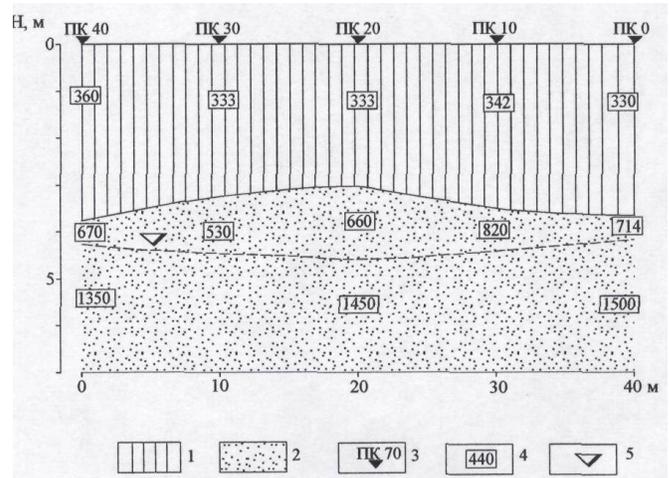
Fig. 4. The seismic section of ground of Juma mosque:
1 – antropogen grunt; **2** – sand; **3** – Seismic monitoring points;
4 – Speed of seismic мулкин; **5** - water level of underground

Additionally, as a result of the seismic electromagnetic researches seismic section graphics were created for the territory of the foundation of mosque tower (Figure 4). According to the results of scientific research, the foundation of the mosque tower influenced of the moisture with around the 4.0 x 5.0 m in size ground, due to soil and underground waters, and the waters coming down from the roof atmosphere, also the tower gone to the east side from its vertical axis. / 3/ Next to the tower, it has water flowing gutters in the 3-5 m distance from foundation, which causes wetting and the east side of the tower in turn affected. Particularly in the current technical condition of the roof of the mosque is not satisfactory, the roof has water dropping. The roof came up to make to be repaired. The longitudinal and transverse wooden beams of a flat roof's top consist of the ramp with 1-2% slopes. In 1947 year, in the reconstruction works of under part of the mosque's roof was not repaired as the original raw (archival documents). In 198, it was opened in order to repair and the roof structure of the mosque was as follows:

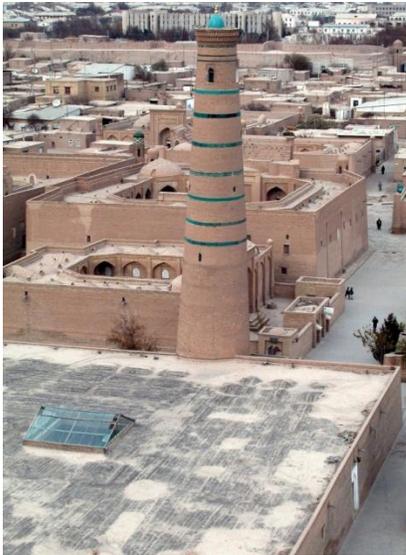
Fig. 5. Full view of the roof of Juma mosque

- * In particular, ruberoid, which is on the straw-clay, has been soaked condition in the autumn, winter and spring, and become brittle, due to rain and snow water. Certainly, it has caused to the corrosion of the crevice of ruberoid, as a result it has lost its waterproof property, and these allowed passing water dropping.
- * Sadly, the ramp on the roof is too low, because of the flat roof, precisely, the total area of 1-2% instead. In turn, this caused the gathered atmospheric water on the roof for a long time, and caused the increase the mass of the layers (Figure 5).

To conclude with, the roof of Juma mosque is needed immediately repaired, because in the water dropping time the water of atmosphere increases the influences of deflection wooden construction by the termites, as well as, significantly influences longitude bending of columns, in a result, strengthen columns by the height load might bent, even simply cannot withstand the earthquake falling. We hope in the future, officials will fully repair this unique architectural monument, and "Wood Museum", which is unique in Central Asia, will be attracted by the foreign tourists of the seven climates of the world throughout the centuries.

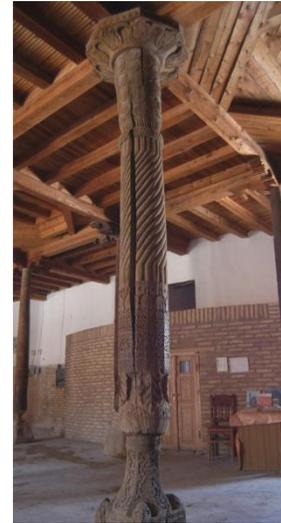
During that period, the project prepared by the engineer M.I.Burshteyn on the roof of the mosque to reopen closing lightweight construction, proposed the use of raw materials. However, the roof repair work has not been shown as in the project. The responsible people used a cane instead of a layer of 1 floor pergamin, which should be used expanded clay, as well as reinforcing materials were not used, because of shortage for the reconstruction of the roof of the mosque project. By a commission set up in 1983 year to correct deficiencies in the above, straw and clay plaster on 30 mm armotsement layer on the project and the 4-storey ruberoid recommended the necessity of laying carpet, but at the end it is not finished. At the moment, the wood used for roofing beams is varied from the ancient wooden beams structure, in terms of specific weight. Therefore, lifting the wooden columns is in a longitudinal bent. Namely, it gives highly strong deformation influence from above (Figure 6).

Fig. 6. The column is bent by longitude and dangerous hole has created

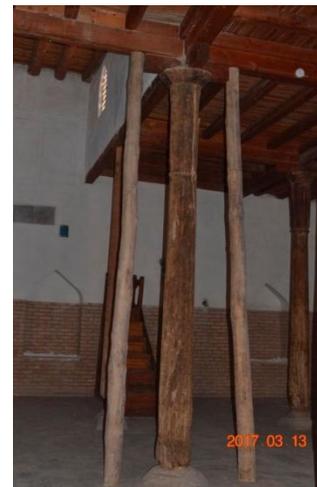
Constancy load of the wooden poles to the down, as well as incorrectly chosen roof materials for repairing and taking into account of the increasing weight to the roof, due to atmospheric effects of rain, the stake is increasing day by day (Figure 7). Even, one column of the mosque which appears covered with a metal belt in order to stop opening a pole at the longitudinal gaps. This method is quite dangerous, because this metal on the belt might get away from the load after a certain time, under the influence of stress, and with the great power affect around people and other columns.

Fig. 7. Assistant hasps have taken to columns

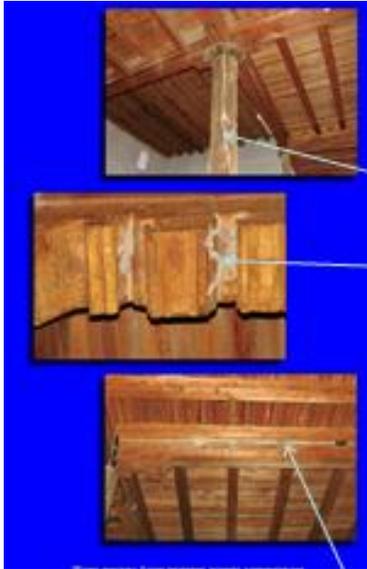
The incorrect usage of the reservation cotton and grain, during the Juma Mosque served as a warehouse (1940-50) period, influenced the monument. Unique wooden columns that time the most affected. According to the results of the monitoring, wooden columns were damaged for mainly two following characters: 1. Mechanical damage (bent, tilt, cracks, etc.) 2. Biological damage (insects, termites, mold, etc.). The majority of the columns of the mosque were infected by biological effects of the termites (30%) (Figure8). Nowadays, scientists of the Ma'mun Academy prepare special feed anti- termites in a laboratory and use for Juma Mosque.

Fig 8. The woods affected by termites
