A Review Over Major Gas Blowouts In Bangladesh, Their Effects And The Measures To Prevent Them In Future

Md. Ashraful Islam Khan, Fuad Bin Nasir

Keywords: Gas blowout, Sylhet-1, Sylhet-4, Moulvibazar-1, Chattak-2, Blowout effects, Blowout prevention.

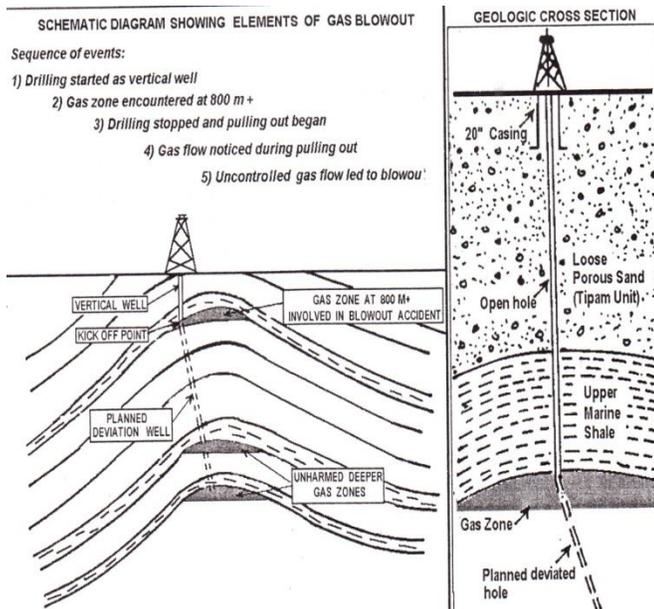
Fig. 3. Schematic diagram to demonstrate the Magurchara blowout effect (left) and a selection through subsurface rock sequence [3].

This subjected well was targeted to drill to a depth of about 3400 m below the surface and the drilling was conducted through a loosely consolidated sand layer named Tipam Sandstone Formation in the shallow subsurface and then through a consolidated shale layer known as Upper Marine Shale (UMS) without setting casing in the loose Tipam Sand unit above the UMS. The well encountered a gas zone at a depth of about 800 meters from the surface. After drilling a depth of 840 meter as vertical well, drilling stopped by the drillers and they started pulling out the drill pipes in order to make arrangement for well deviation from its vertical path, but during the pulling out operation that gas from the gas zone below, rushed into the drill hole, forcing

its way up which eventually caused the blow out of the well [3].

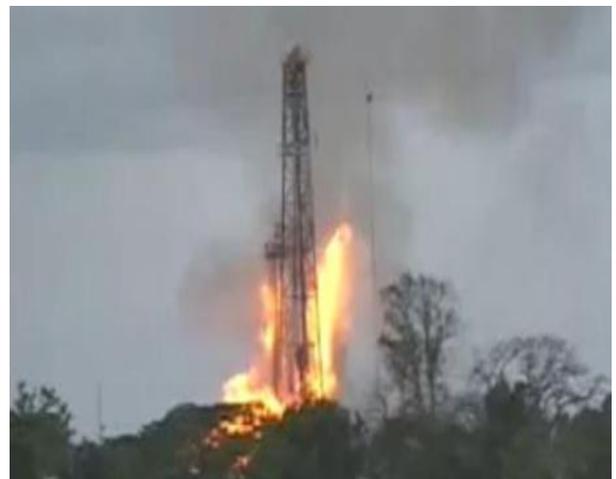
Fig. 4. Magurchara blowout

A massive blowout torn apart in the Magurchara gas field in Moulvibazar's Kamalganj upazila while the US energy company Occidental was drilling a well there. The massive blaze that the blowout triggered wiped out property worth crores of taka. At Magurchara, the affected people expressed their dissatisfaction to this correspondent over the role of the successive governments in realizing the damages. They wanted to know the mystery behind the long government silence when it comes to settling the compensation claims. The flora and fauna of the Lawachara Reserve Forest adjoining the exploded well took the brunt of the explosion. The flame destroyed a teak grove raised between 1944 and 1950, bamboo shacks created between 1993 and 1995, and a strip of plantation established in 1994. About 96 acres of Lawachara forest were completely burnt. Fifty percent of the forest resources on 111.15 acres of land and 30 percent resources on 106.21 acres of land were also damaged. Experts said the loss is irrecoverable. Since the fire, wild animals stray into households on the outskirts of the forest in search of food. According to the committee reports, the damage to forest resources amounted to Tk 9,858 crore, while 29 tea gardens of the area suffered a loss of about Tk 46.07 crore. The railway suffered a loss of Tk 21 crore, Jalalabad Gas Company Tk 43 lakh, the electricity department about Tk 4.35 crore. Indigenous Khasia people lost betel leaf plantations worth Tk 18 lakh [12]. Another unofficial expert committee, appointed by the National Committee to Protect Oil-Gas-Mineral Resources and Port (NCPGMRP), after an investigation revealed that the blowout caused an estimated Tk 9000 crore loss to the nation and gas reserve of about 245 billion cubic feet was burnt in the explosion while the environment, ecology and wildlife of the area were also severely affected [8].

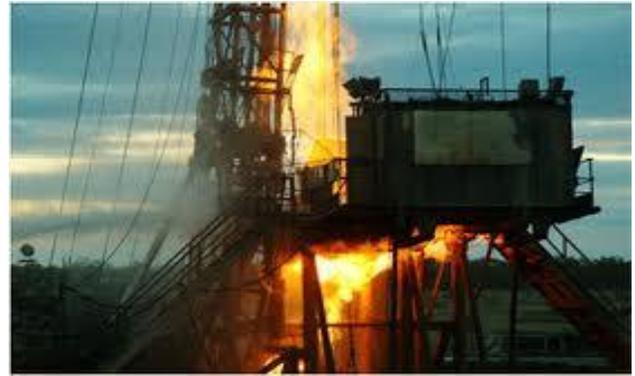
Fig. 5. Tengratila blowout

On January 8, 2005, ten thousand of panic-stricken people fled their homes as a drilling-well exploded in Tengratila gas field. The raging flames were visible from 30 kilometers away at this gas field. The explosion of Niko's Tengratila gas field led to millions of cubic feet of gas burning [10, 11].

Second blowout occurred on June 17, 2005, just six months after the first explosion [13]. The gas field burnt for a couple of months and no instant effective measures were taken by the concerned authority [11]. The Department of Environment (2005), submitted a report to determine the loss of environment and found soil of the surrounding field more affected. Generally the configuration of the land of the areas is northeast hilly, northeast alluvium and some areas of Sylhet basin. As a result of blow out the surroundings are hilly, rift valley, small mound, and low lands were affected by the emission of gas and sand. Surroundings of the blowout area like Tengrabazar, homestead area, forest trees, and hilly fruit bearing trees were affected by the fire. Underground sand and clay soil were throughout with gas from the main field to 2-3 km areas of the Tengratila. Total loss of soil resources was divided into 4 categories named as most affected areas, very affected areas, moderate affected [14].
