Developing A Simple Survey Procedure For Seismic Risk Evaluation In 2012 Thabeikkyin Earthquake, Upper Myanmar

Nan Pawt Sai Awar, Dr. Aye Mya Cho

Keywords: simple procedure, seismic risk, evaluation, local houses, Thabeikkyin Earthquake

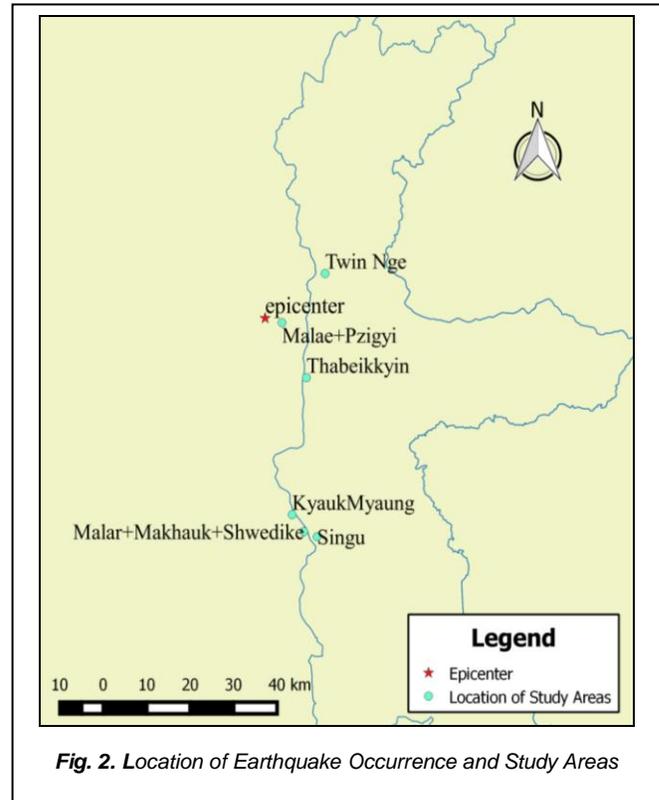
According to 2012 Thabeikkyin earthquake, some areas were affected during earthquake, namely Mandalay, Inwa, Amarapura, Sagaing, Thabeikkyin, Kyauk Myaung and Singu in Mandalay District and Sagaing District, and especially Thabeikkyin Township, Kyauk Myaung Township and Singu Township had severely damaged. Field investigations have been carried out Twin Nge village, Ma Lae village, Thabeikkyin Town, Kyauk Myaung Town, Ma Lar village and Singu Town. These are the most affected areas during earthquake. Location of earthquake epicenter and main affected areas are shown in Fig. 1 and location of earthquake occurrence and study areas are shown in Fig. 2.

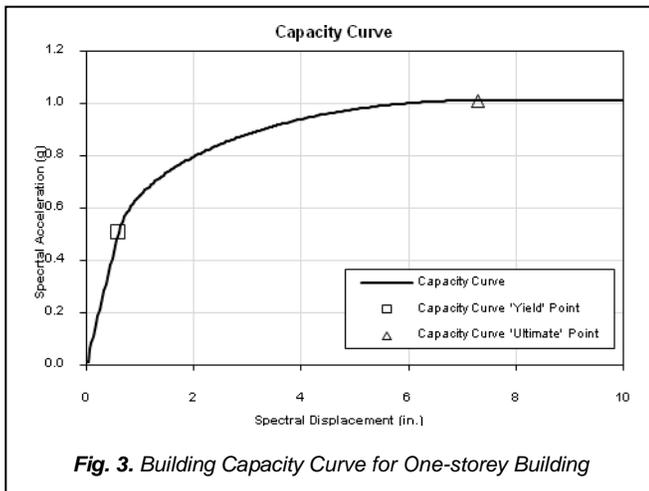
Fig. 3. Building Capacity Curve for One-storey Building

For one-storey building, A_y and D_y values are 0.50625g and 0.608 in, and A_u and D_u values are 1.0125 g and 7.296 in. The elliptical portion of capacity curve, the values of k , b and a are 0.45, 0.5625 and 6.7217. Also for two-storey building, A_y and D_y values are 0.46875 g and 0.663 in, and A_u and D_u values are 0.9375 g and 7.96 in. The elliptical portion of capacity curve, the values of k , b and a are 0.4167, 0.5208 and 7.3336. The selected study areas are in Very High seismicity region (in

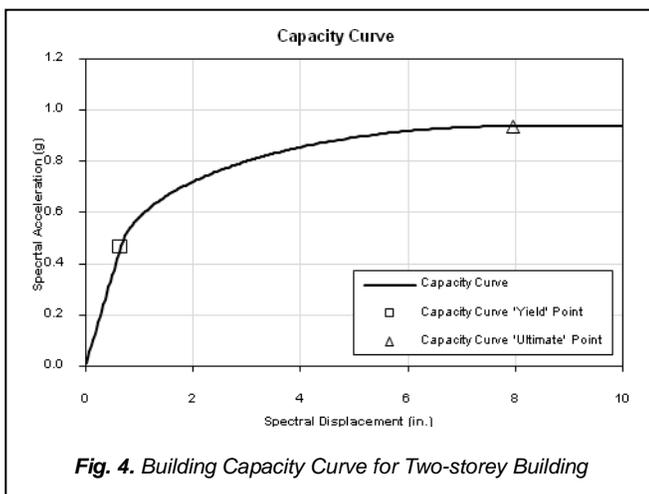
Fig. 4. Building Capacity Curve for Two-storey Building

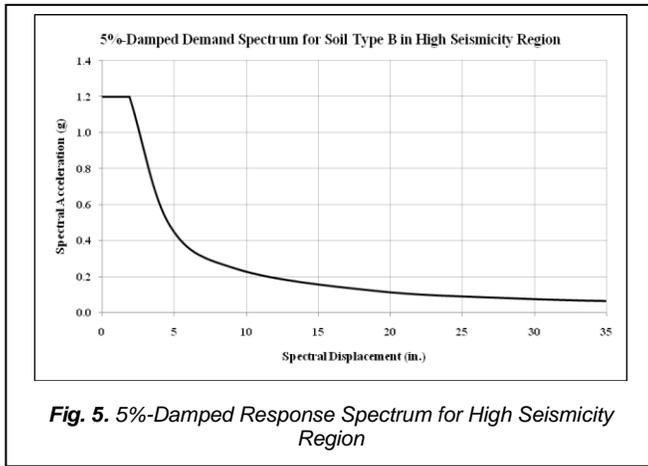
Fig. 5. 5%-Damped Response Spectrum for High Seismicity Region

To develop a 5%-damped response spectrum, it has to find the following values. For the High seismicity region, $S_{MS}=1.20$ g, $S_{M1}=0.48$ g, $\beta_{eff}=5\%$,

$$R_A = \frac{2.12}{3.21 - 0.68 \ln(\beta_{eff})} = \frac{2.12}{3.21 - 0.68 \ln(5)} = 1.00$$

$$R_V = \frac{1.65}{2.31 - 0.41 \ln(\beta_{eff})} = \frac{1.65}{2.31 - 0.41 \ln(5)} = 1.00$$

$$T_S = \frac{S_{M1}}{S_{MS}} \times \frac{R_A}{R_V} = \frac{0.48}{1.20} \times \frac{1.00}{1.00} = 0.4$$

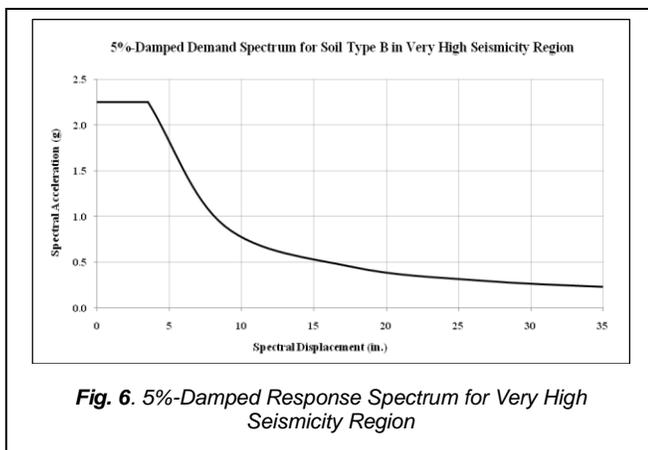
Fig. 6. 5%-Damped Response Spectrum for Very High Seismicity Region

For the Very High seismicity region, $S_{MS}=2.25$ g, $S_{M1}=0.90$ g, $\beta_{eff}=5\%$,
 $R_A = 1.00$
 $R_V = 1.00$
 $T_S = 0.4$

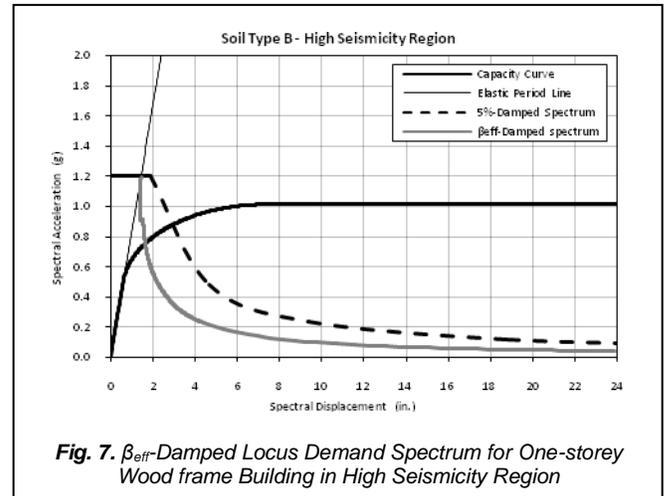
Fig. 7. β_{eff} -Damped Locus Demand Spectrum for One-storey Wood frame Building in High Seismicity Region

From the overlay of the capacity curve and demand spectrum shown in Fig. (7) through Fig. (10) the peak responses are taken as 1.642 in, 1.78 in, 3.86 in and 4.23 in. This is compared to the elastic displacement, D_e , as shown in Table 9. After getting the peak response values, the fragility curves are developed with the medium value of the Complete (C) structural damage state with the following equation.

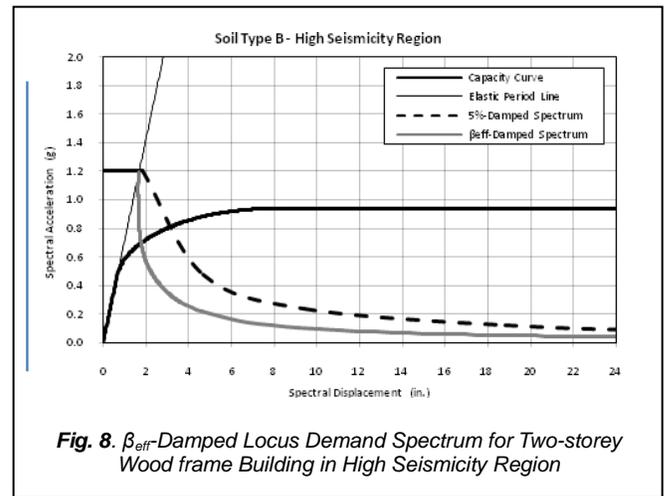
Fig. 8. β_{eff} -Damped Locus Demand Spectrum for Two-storey Wood frame Building in High Seismicity Region

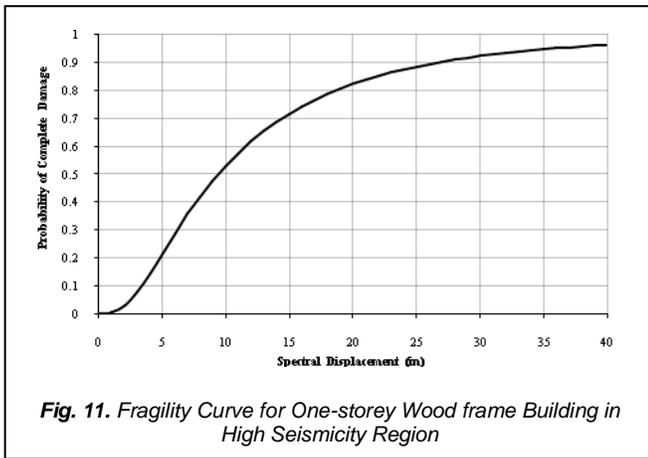
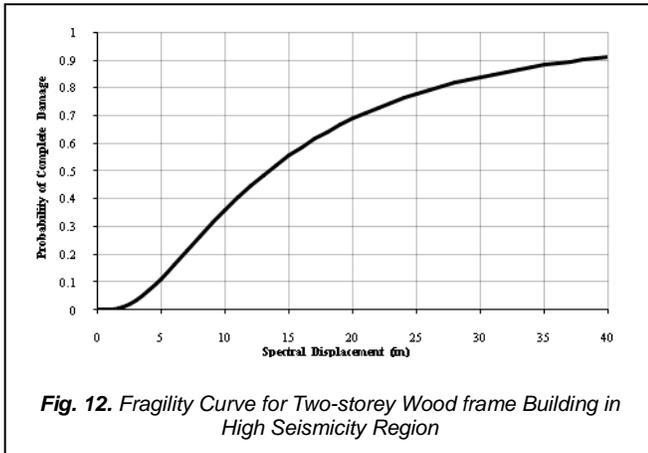
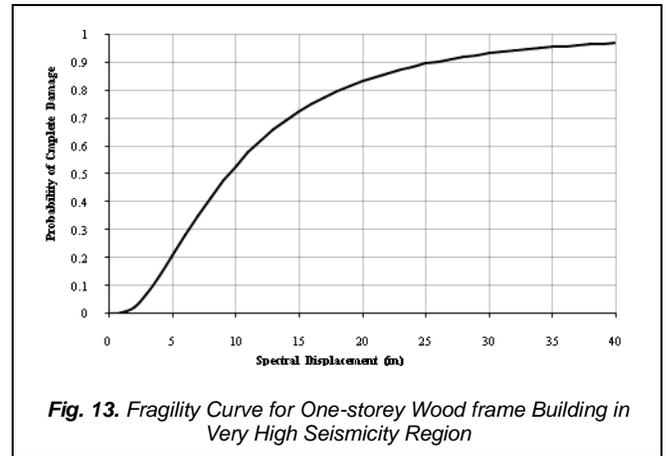
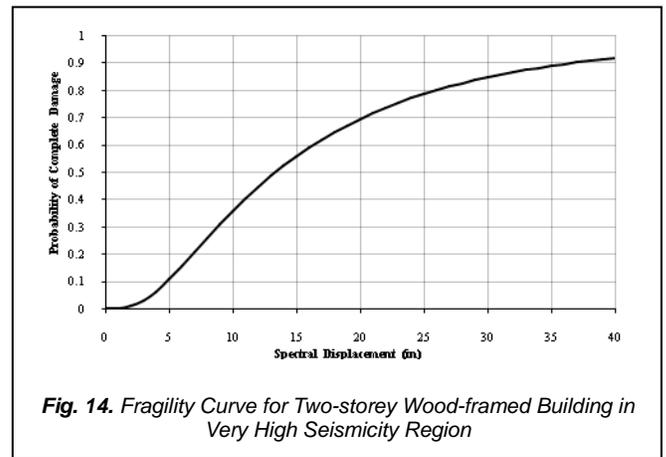
$\beta_{C,D}$ is determined using Appendix A Table A-10 in FEMA P-155. β_{CAP} and $\beta_{T,C}$ are taken as 0.3 and 0.4. X is taken as 0.75 for all FEMA P-154 calculations. D and D_e are taken above. The $\beta_{C,P}$ values of the one- and two-storey buildings in High and Very High seismicity regions are 0.81024, 0.8216, 0.7798 and 0.7895. The resulting fragility curves are defined by the following equation and are shown in Fig. 11 through Fig. 14.

$$P[\text{Complete Damage}] = \varphi \left[\frac{1}{\beta_{C,P}} \ln \left(\frac{D}{S_{d,C}} \right) \right] \quad (16)$$

After this, the probability of complete damage is determined at each peak response. Therefore, the probabilities of complete damage are 0.0154 and 0.007 for one- and two-storey wood frame building in High seismicity region, and 0.1254 and 0.0722 for one- and two-storey wood frame building in Very High seismicity region. From the resulting values, the probability of collapse is determined by using the following equation.
