Measurement Of Hydraulic Pressure Fan Motor In Engine D1551a-6 With Modification Tool Adapter

Abstract: In the world of heavy equipment has been achieved with the development of various methods used to improve product quality. Over time, many problems are experienced in the unit, one of which is the problem experienced by unit D155A-6 engine overheat caused by abnormal fan motor. The purpose of this research is to make adapter tool for measuring fan motor hydraulic pressure in troubleshooting engine overheat on unit D155A-6. The measurement results indicate that the Fan Motor is in abnormal condition and must be replaced. To determine the Preasure Oil Hydraulic Fan Motor and not to repeat the same thing when the same problem occurs, it should be made adapter tools with the results can save expenses with price comparison (before and after) the availability of tools for: (\$3.888 - \$486) = \$3.402.

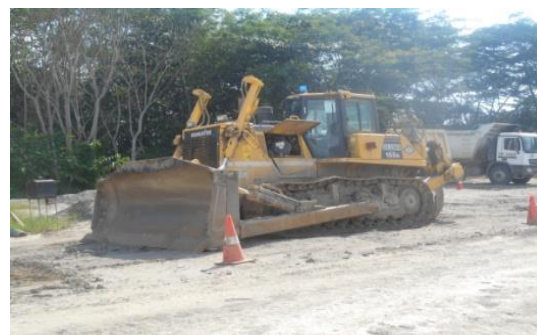
Figure 1. Unit D155A-6 (Purwono, 2017)

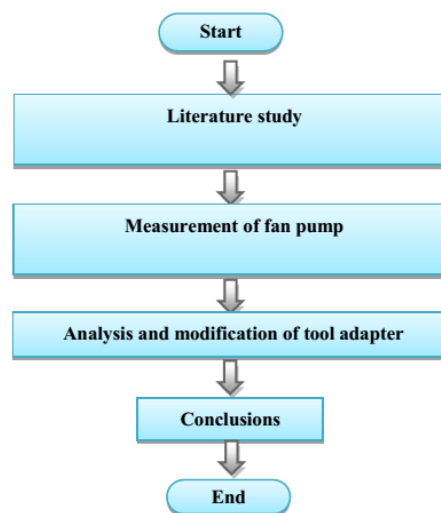
Figure 2. Flowchart of this research

The following is a flow of research conducted in accordance with Figure 2.

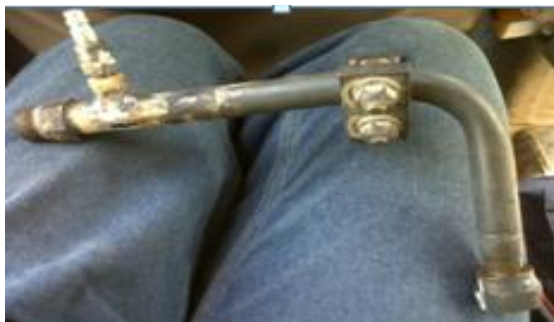
Figure 3. Component of piping modification

The first step of this research is to make measurements to the fan pump for approximately two days constrained to determine the preasure oil hydraulic Fan Motor, so to

shorten the work done modification piping on Fan Motor, can be seen in Figure 3.

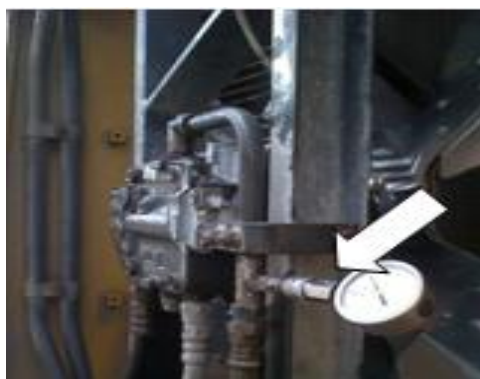
Figure 4. Fan Motor components after fabrication

The next step is the modification done on the piping with the addition of nipple mounted on the piping by way of fabrication, as in Figure 4.

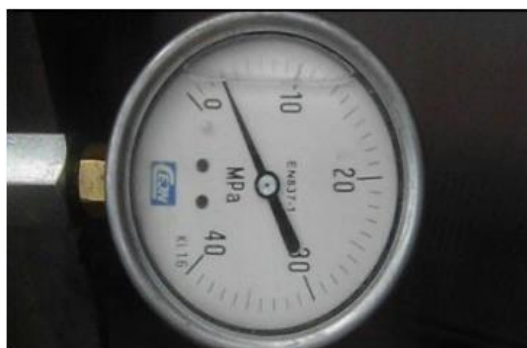
Figure 5. Measurement of Low Idle Motor Fan

After the modification on the Fan Motor then can continue the measurement to determine the Fan Motor is still normal / not, can be seen in Figures 5 and 6.

From the result of measurement result above Fan Motor condition at Low Idle 4 kg and High Idle condition equal to 8,5 kg at 100% Fan motor mode. The measurement results indicate that the Fan Motor is in abnormal condition and must be replaced. From the results of the above analysis to determine the duration of the measurement results so that the unit breakdown time is too long and by modifying the Fan Motor if lack of safety that can cause leaks in the fabrication results due to material differences. To not repeat the same thing when there is the same problem then the author took the initiative to create tools to determine the Pressure Oil Hydraulic Fan Motor.

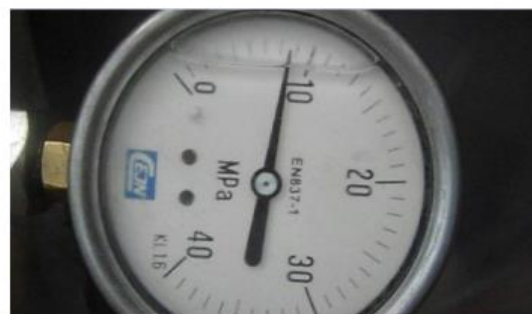
Figure 6. Measurement of High Idle Motor Fan

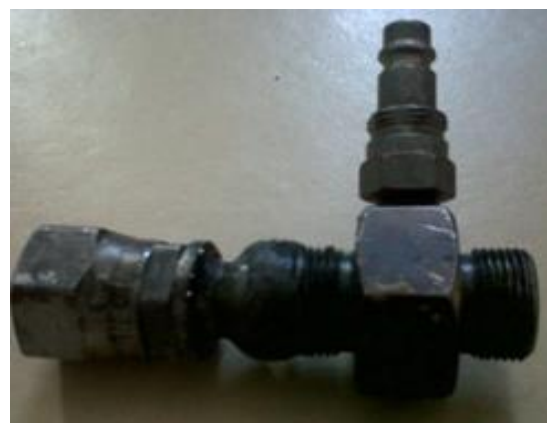
Figure 8. Tools Adapter

Below is a schematic drawing of the modification of the adapter tool, shown in Figure 7-9.
