# Analyzing Issues Of Housing For Post Disaster Rehabilitation: A Study Of Land Slide Rehabilitation At Chittagong, Bangladesh

Kanu Kumar Das, Mainak Ghosh, Shajib Paul

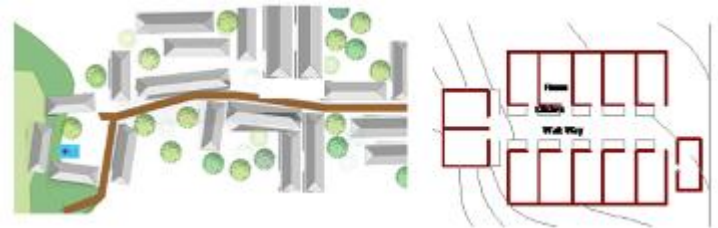
Figure 3: Conceptual Layout Plan

Layout Pattern: There is irregular pattern in the housing of that study area as shown in Fig. 4 & 5.

There are different layout plans of the houses in the study area. The most common and vulnerable shelters are in group sharing with common toilet and kitchen facilities. These houses are connected with a narrow corridor and some of them are very near to hill. Common water supply and electricity facility are there. The drainage system is not proper and there is no consideration of rainwater drainage. People living the landslide prone area are mostly illiterate, day laborer and garment workers, low income people, migrated from outside of city mainly for the job, have weak housing infrastructure, have

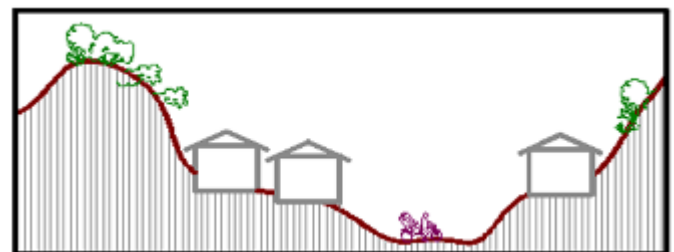
**Figure 4 Conceptual Cross Section of the settlements**

Like most other informal settlements in Chittagong, Biojeed Bostami, Motijahna informal settlement has been built on vacant government land vulnerable to natural disasters - a landslide. A lot of houses are built on the edge of the steep slope, hill top and foot of the hill. This practice makes them extremely vulnerable to landslides. According to the survey report of the students of CUET, the building of Motijorna settlement is in four types – Katcha, Semi pucca, Pucca and Multistoried. Katcha House: Katcha house mainly is built with the cheapest and temporary materials, The Foundation is made earthen plinth with bamboo (sometimes timber) posts. While the wall is made of with organic materials - jute sticks, catkin grass, straw, bamboo mats, etc. and split bamboo framing. Here the roof is of CI sheet.

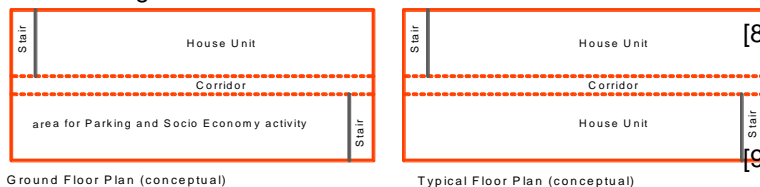
**Figure 10:** Plan of Builtform

For rehabilitation of any settlements the important issues are considering their life style, their affordability, job opportunity, transportation and safety. Their affordability depends on their income and expenditure which is related to their transportation, housing condition, availability of services. The built form should be simple with the dimensions according to their affordability. The area of these houses proposed for the rehabilitation of people is calculated to be close to 20 sq.m., including bedroom, kitchen, toilet and common spaces as shown in Fig. 10.
