Examination Of Mechanical Properties And Weld Zone Of X70 Pipe Steel After Welding

Zakir Tas

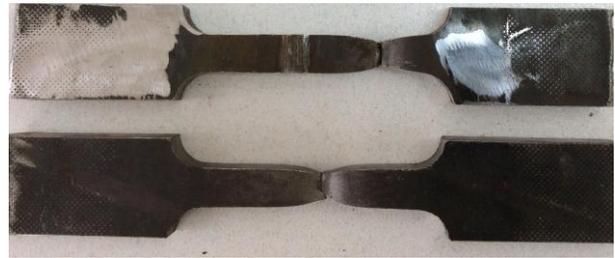
The rupture in the welded samples as a result of tensile test occurred outside the weld zone, i.e. in base materials (Figure 3). Table 5 shows the strength and elongation (%) values obtained from the tensile tests.

Fig. 3. Tensile samples.

When Table 5 was examined; it was found that tensile strengths of base material and welded sample were 669 MPa and 735 MPa, respectively, and the elongation values (in %) of the base material and welded material were 27.5% and 18.4%. It was observed that tensile values of the welded samples were higher than the tensile values of the base material. Even though the rupture occurred in the base material, the elongation values (in %) of the welded samples were lower. This is because no deformation occurred in the welded zone during tensile test [6]. The higher heat-flow occurs in the submerger arc welding process compared to other welding processes. High heat-flow in turn causes an increase in the hardness of material. As both hardness and tensile strength indicate the resistance of metals against the plastic deformation, these two values are roughly proportional. In other words; the rupture was caused by the base material with lower hardness instead of the weld metal or HAZ which confirms this result [7]. It was observed that the resistance of weld zone against the deformation resulted in an increase in tensile strength and a decrease in the elongation value (in %). In addition to the additional micro-alloy elements, all of the fine grain steels, depending on their producers, contain Mn to increase the yield point and strength. Ni is mostly added to improve the toughness of notched bend impact at low temperatures other than Mn. The yield point is increased by adding the limited ratio of Cu in proportion to Ni ratio without leading to disadvantageous results for the toughness of notched bend impact and weldability [8].

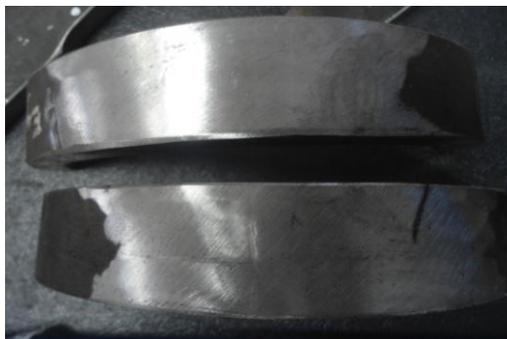
Fig. 5. Bend samples

- It was determined that tensile and hardness values of the weld metal increased compared to the main material, on the other hand, the toughness value decreased.
- The guided bend test was applied to the welded samples on the face and root sides and no defects such as crack, rupture, etc. were observed. Thus, it was concluded that the welding process was carried out properly.
