Analysis Of Vacuum Failures During Curing Of Cfrp Composites.

Mr. K.Vijaya Kumar, Dr. Mir Safiulla, Dr. A.N Khaleel Ahmed

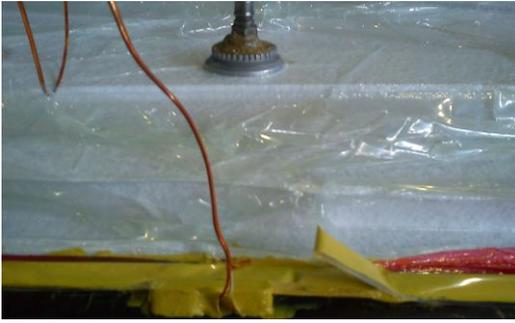
The bagging film or a reusable elastic bladder is located over the material being cured and sealed against the tool surface as shown in the fig.2 which is called as the restraints or the dams to prevent the lateral motion and to minimize the resin flow parallel to the tool plate and through the edges.

Fig.2 Vacuum bagging with thermocouple and vacuum valve.

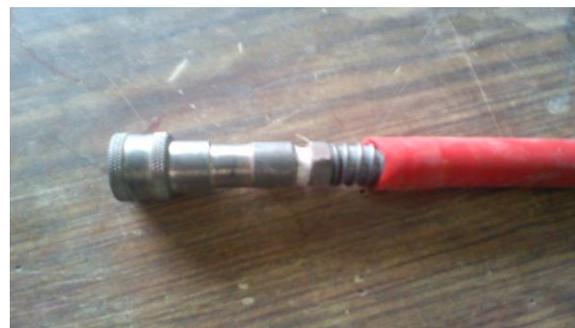
Vacuum hoses and the valves that are fitted with the connectors or the male plugs as shown in the fig 6. are properly tightened and checked before connecting it to the part to ensure the leakages. If the hoses and the valves are not fitted properly, it may read maximum vacuum initially, but at some point after application of pressure it fails abruptly causing part rejections due to defects. If part geometry is more complex to withstand the vacuum then it is more difficult to achieve uniform consolidation and to avoid wrinkling.

Fig.6 Vacuum hose fitted with the connector.

5. A vacuum failure during curing also occurs due to leakage in vacuum hoses and Vacuum valves. Hence these are to be checked before using it for curing for every cure cycle.

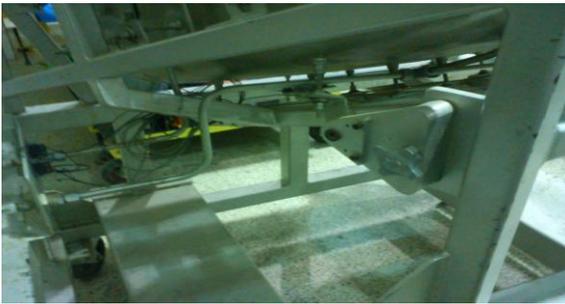
At present latest NMG metallic tools with nickel coating have inbuilt vacuum lines for suction and measurement which avoids the use of vacuum valves and also saving in bagging time as shown in the fig 7. But when an external pressure is applied on the prepreg stack that causes the excess resin to flow into bleeder. Sometimes due to improper bagging the resin flows in to the inbuilt vacuum lines and blocks the lines that causes defects in the cured part, hence the vacuum lines needs to be ensured for proper vacuum flow after every curing.

Fig.7 NMG metallic tools with inbuilt vacuum lines form suction and measurement.

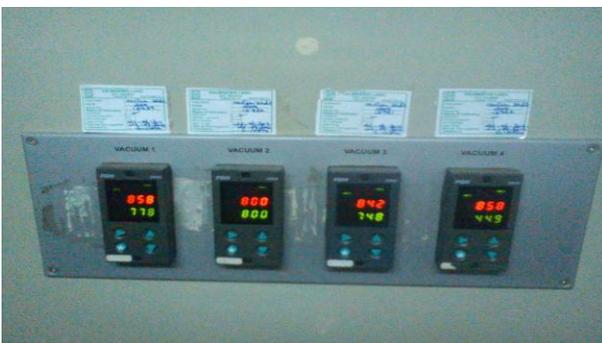
Vacuum controllers fitted with the autoclaves are to be calibrated periodically to ensure the safe working condition as shown in the fig. 8.

Fig.8 Calibrated autoclave Vacuum controllers.

Even the solenoid valves are ensured to work in auto mode for continuous supply of vacuum during the curing process in autoclaves.

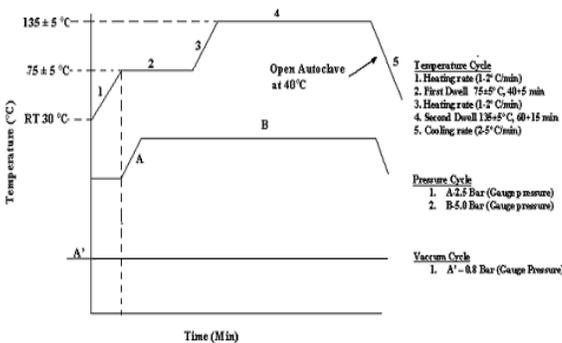
Five Test Laminates of size 200 x 200 made of carbon BD V913/40%/G801 . The prepegs are cut along the fiber wrap direction for the symmetric balanced layup sequence . It is cured as per the manufacturer recommended cure cycle as shown in the fig. 9. Vacuum levels are varied at each stage.

Fig.9 Manufacturers recommended two step cure cycle where the vacuum is applied throughout the cure process.
